# LYNG CHURCH

Fredericia, Denmark

Roof: 2,000 m<sup>2</sup> 15 t Double Standing Seam  
RHEINZINK-prePATINA blue-grey

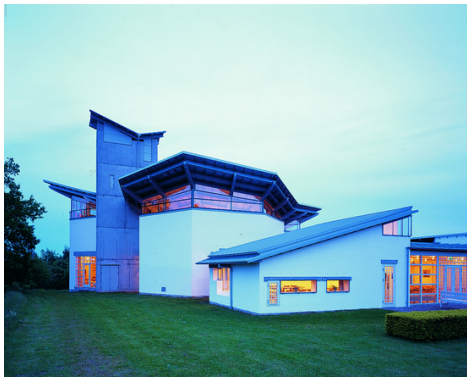
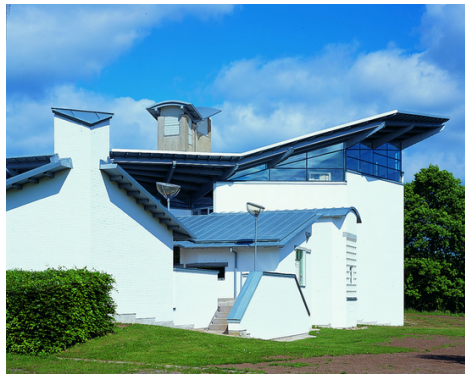
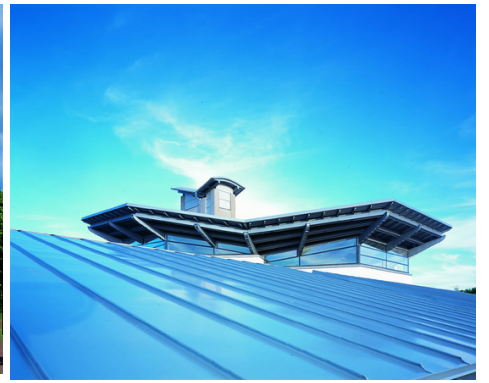
To achieve an optimal airflow, the cladding on the back of all main girders, roof trusses and rafters is made of perforated zinc. The zinc overhang cladding is made with an air gap at all edges - also in perforated zinc. Perforation with a hole diameter of 3 mm. was chosen, as this hole size ensures that bees and other insects are not able to enter the ventilated cavities.

A new zinc cladding in the surface RHEINZINK prePATINA was mounted everywhere at an underlayer of 15 mm high, perforated zinc hat profiles due to extensive rot damage in roof ridges and roof edges. All rotten wood was replaced and painted before the zinc cladding was mounted. By mounting the perforated profiles, an 18 mm. ventilated cavity was ensured between the zinc cladding and the existing wooden structures.
